INDOOR AIR QUALITY ASSESSMENT

**Elizabeth Pole Elementary School
110 County Street
Taunton, Massachusetts**

Prepared by:
Massachusetts Department of Public Health
Center for Environmental Health
Bureau of Environmental Health Assessment
Emergency Response/Indoor Air Quality Program
June 2005

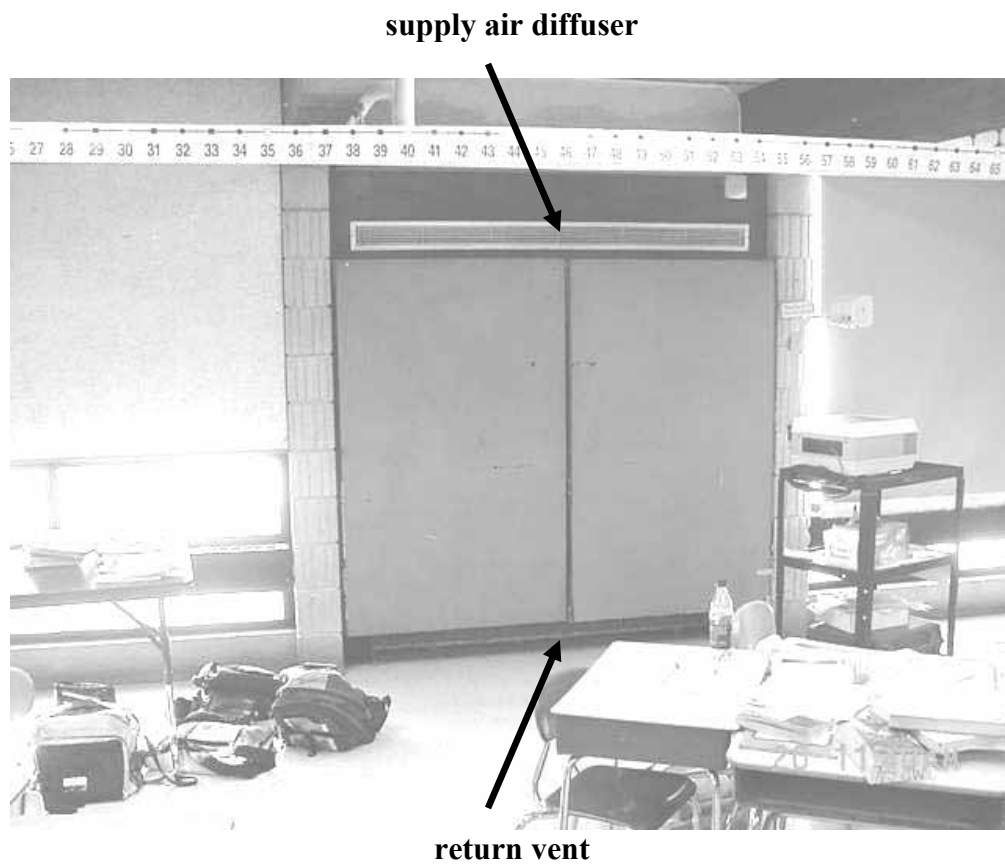
Picture 1

Fresh air in classrooms is supplied by a unit ventilator (univent) system (Pictures 1 and 2). Univents draw air from outdoors through fresh air intakes located on the exterior walls of the building (Picture 3) and return air through air intakes located at the base of each unit ([Figure 1](#)). Fresh and return air are mixed, filtered, heated and/or cooled and provided to classrooms through a diffuser located on the top of the unit. Adjustable louvers control the ratio of fresh and recirculated air. As discussed, during extremely cold temperatures, outside air intake is limited to prevent freezing of pipes. The majority of univents were operating during the assessment; however, some univents had been deactivated (Table 1). Obstructions to airflow, such as furniture located in front

Occupants also expressed concern regarding the presence of mold growth on the surface of corkboards, which are used extensively in a number of applications, including cabinet doors for classroom univents throughout the building (Picture 1). During the initial walkthrough on January 20, 2005, CEH staff recommended the removal of corkboards located directly above sinks. These were removed prior to the February 3, 2005 follow-up visit. In several cases, corkboards appeared to have surface staining, but did not appear to have active mold growth.

Classroom Univent, Note Corkboard Cabinet Doors

2. Clean the surface of corkboards using a high efficiency particulate arrestance (HEPA) filter equipped vacuum cleaner vacuum equipped with a brush attachment if mold growth reoccurs on. If mold growth has *colonized* the corkboard or if growth occurs *repeatedly*, removal or replacement should be considered.

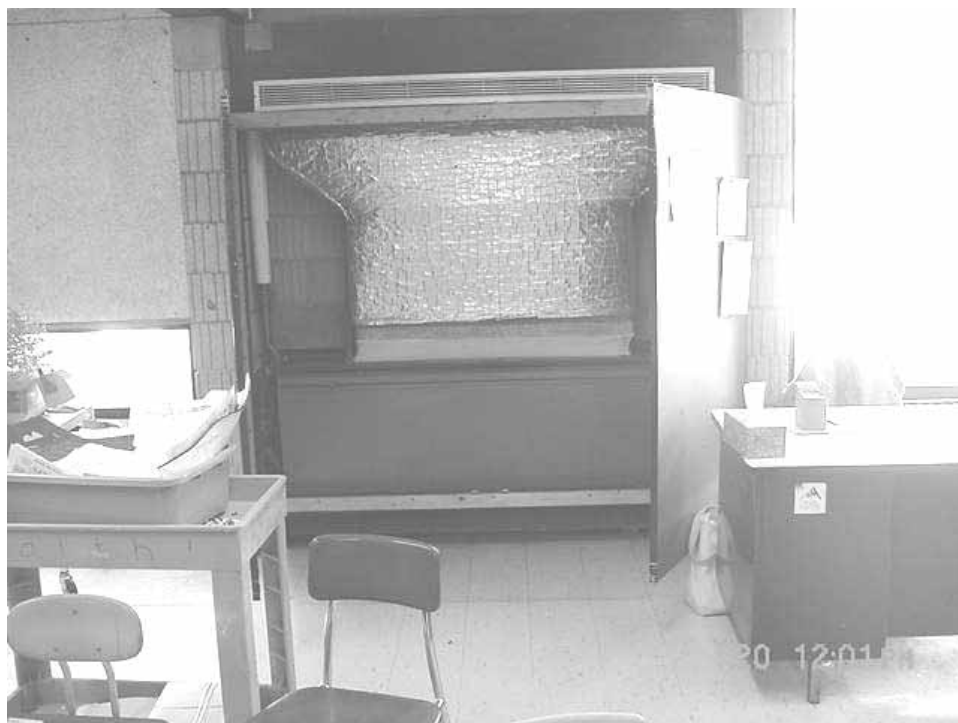
Picture 2

Classroom Univent With Cabinet Doors Opened

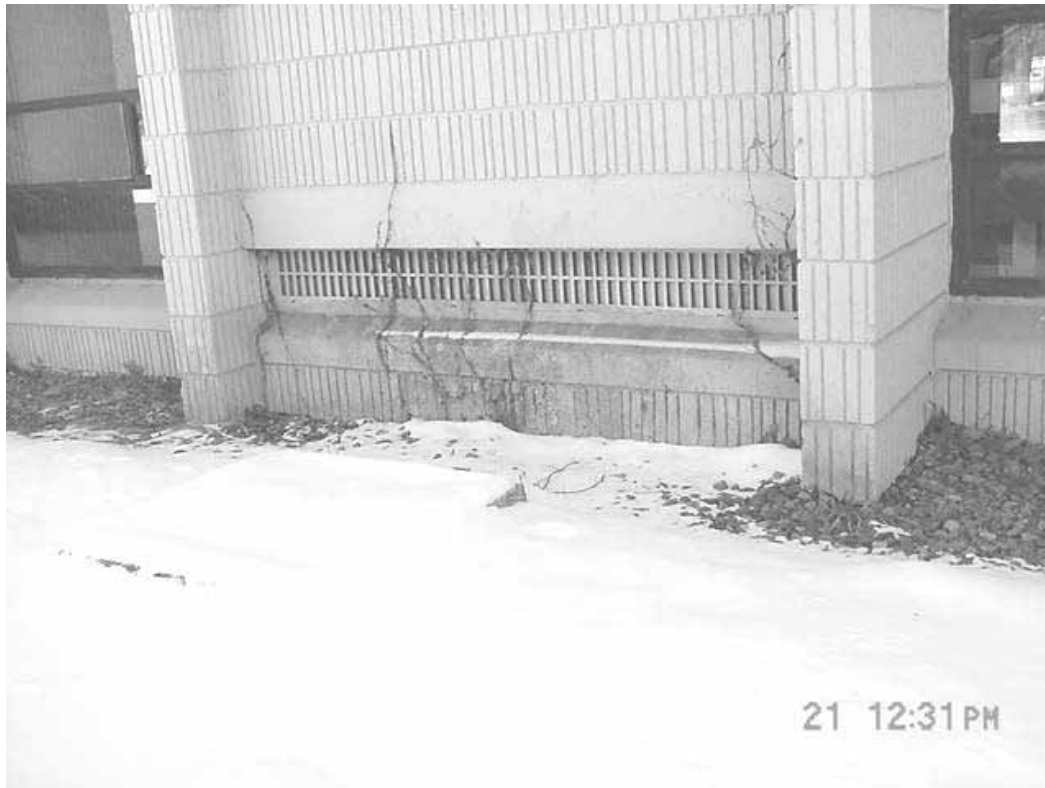
Picture 3

In several areas around the building, small trees/stumps and other plants were observed growing against the foundation. Clinging plants were noted on exterior walls (Pictures 3 and 15). The growth of plants/roots against the exterior walls and along the foundation can bring moisture in contact with wall brick, eventually lead to cracks and/or fissures in the foundation below ground level. Clinging plants can cause water damage to brickwork, since the plants insert tendrils into brick and mortar. Water can penetrate into the brick/concrete along the tendrils. Subsequently freezing/thawing in the winter action can weaken building materials, resulting in wall damage. In addition, plant growth in close proximity to univent air intakes can draw in allergens such as mold and pollen.

Univent Fresh Air Intake, Note Plant Growth in and around Vent

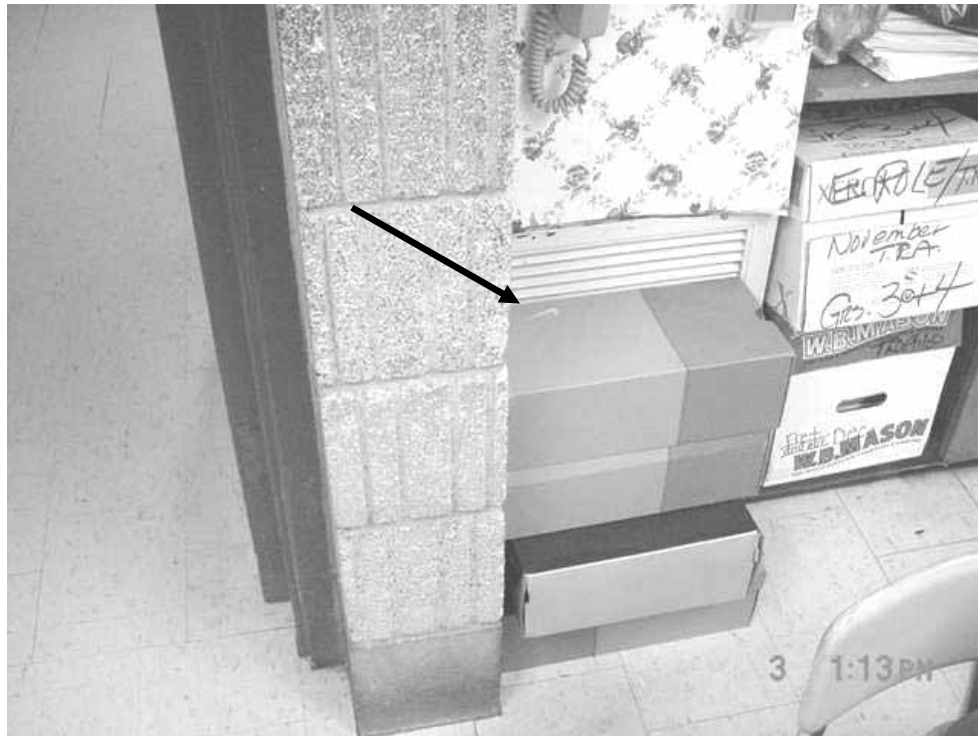
Picture 4

Classroom Exhaust Vent Obstructed by Boxes

9. Remove all blockages from univents and exhaust vents. Close classroom doors to facilitate air exchange.
10. For buildings in New England, periods of low relative humidity during the winter are often unavoidable. Therefore, scrupulous cleaning practices should be adopted to minimize common indoor air contaminants whose irritant effects can be enhanced when the relative humidity is low. To control for dusts, a high efficiency particulate arrestance (HEPA) filter equipped vacuum cleaner in conjunction with wet wiping of all surfaces is recommended. Avoid the use of feather dusters. Drinking water during the day can help ease some symptoms associated with a dry environment (throat and sinus irritations).

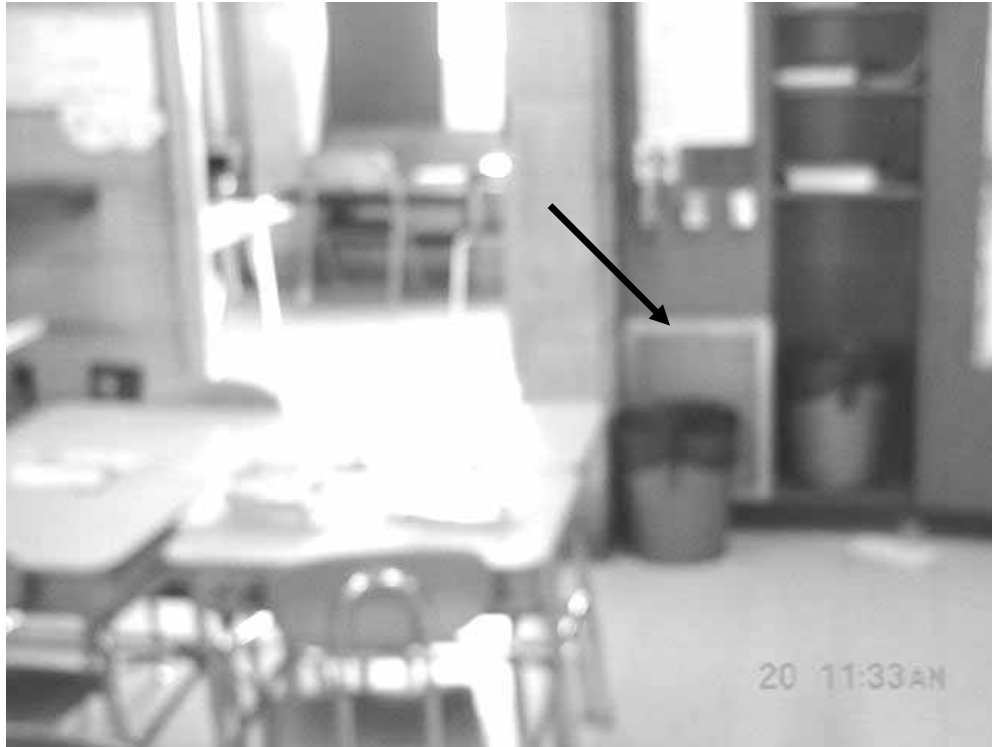
Picture 5

Classroom Exhaust Vent and Open Hallway Door

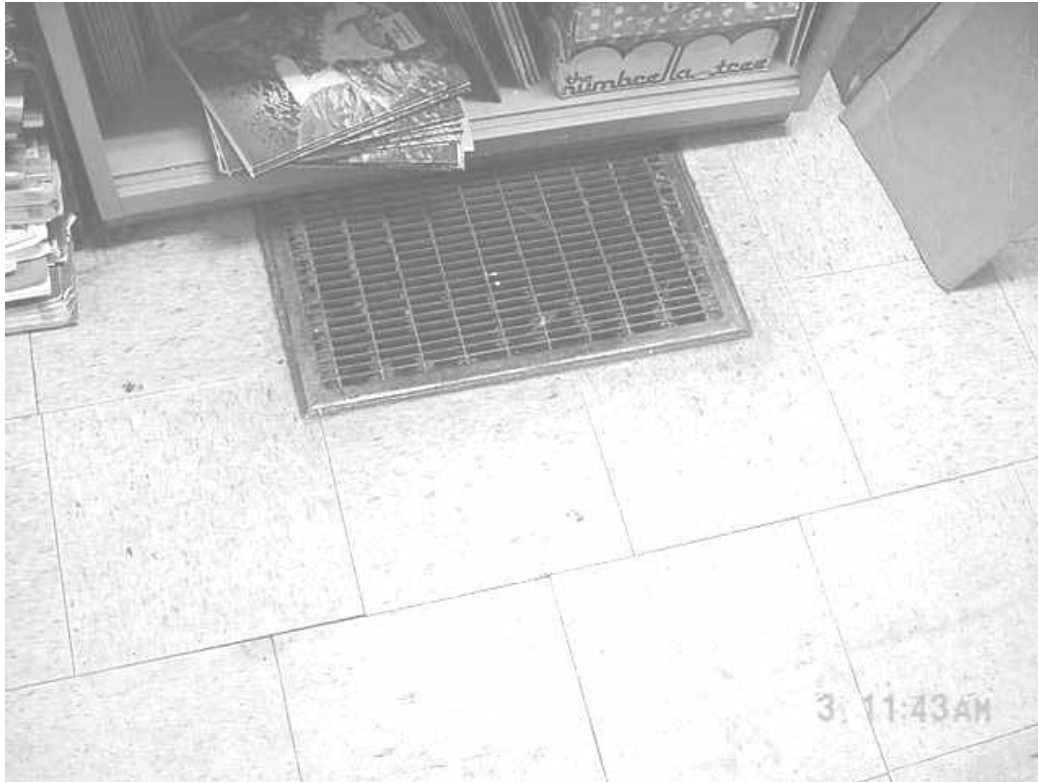
Picture 6

Ventilation for modular classrooms is provided by AHUs. Fresh air is distributed to classrooms via ductwork connected to ceiling-mounted air diffusers and drawn back to the AHUs through floor grilles (Picture 6). Thermostats control each heating, ventilating and air conditioning (HVAC) system and have fan settings of “on” and “automatic”. Thermostats were set to the “automatic” setting (Picture 7) during the assessment. The

Floor Vent in Modular Classroom

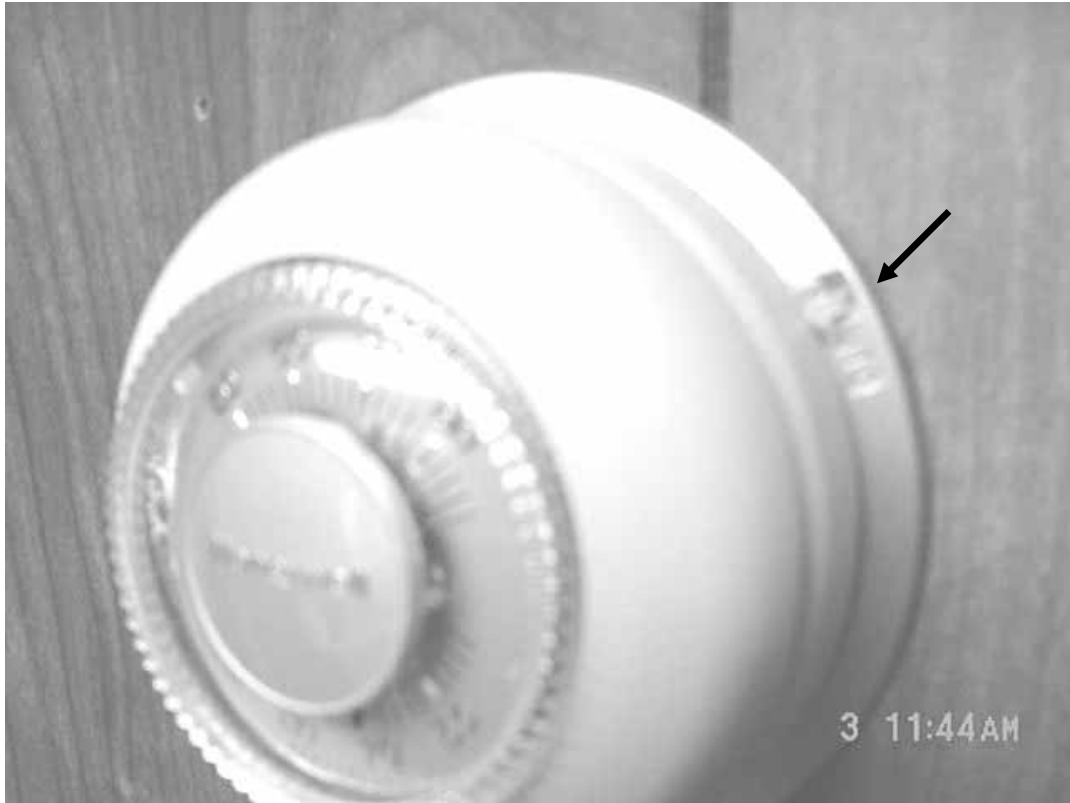
Picture 7

automatic setting on the thermostat activates the HVAC system at a preset temperature. Once the preset temperature is reached, the HVAC system is deactivated. Therefore, no mechanical ventilation is provided until the thermostat re-activates the system.

Modular Classroom Thermostat in the Fan “Auto” Setting

7. Repair and/or replace thermostats and pneumatic controls as necessary to maintain control of thermal comfort. Consider contacting an HVAC engineer concerning the condition and calibration of thermostats and pneumatic controls school-wide.

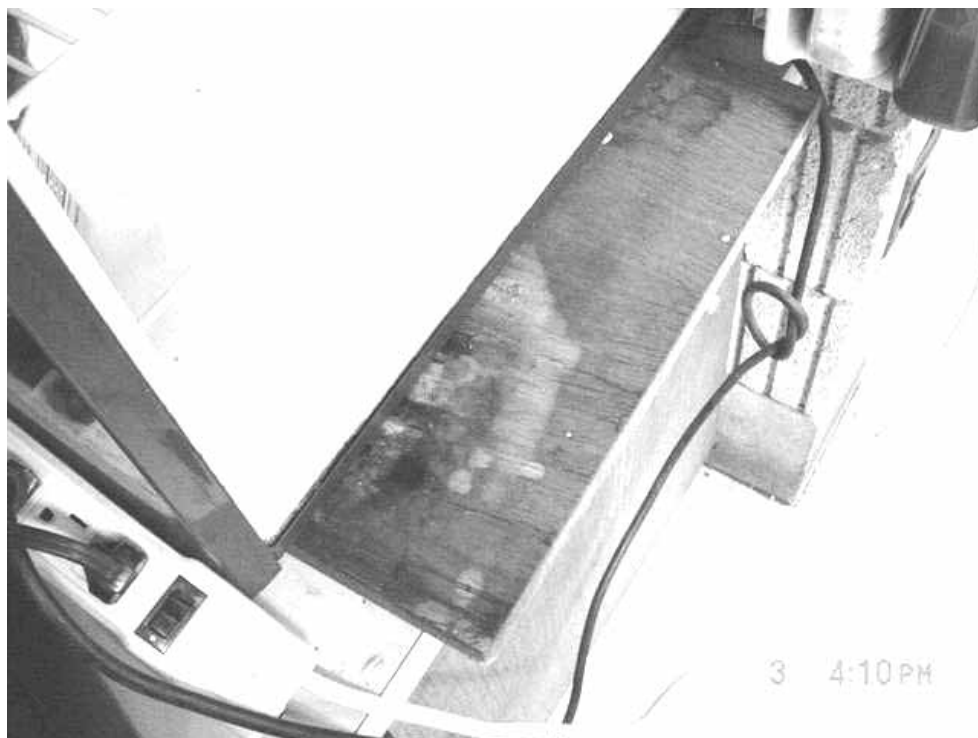
Picture 8

As reported by the TSD and PES staff, a number of materials were either colonized with mold or in contact with mold spores. At the time of the CEH assessment materials in the building that were colonized with mold had either been removed or disinfected. CEH staff did, however, observe visible mold growth in classroom 9. However, this mold growth appeared to be from water damage caused by the use of a small refrigerator placed on a wooden tabletop (Picture 8). This type of equipment generates condensation.

Mold-Colonized Wooden Table beneath Refrigerator in Classroom 9

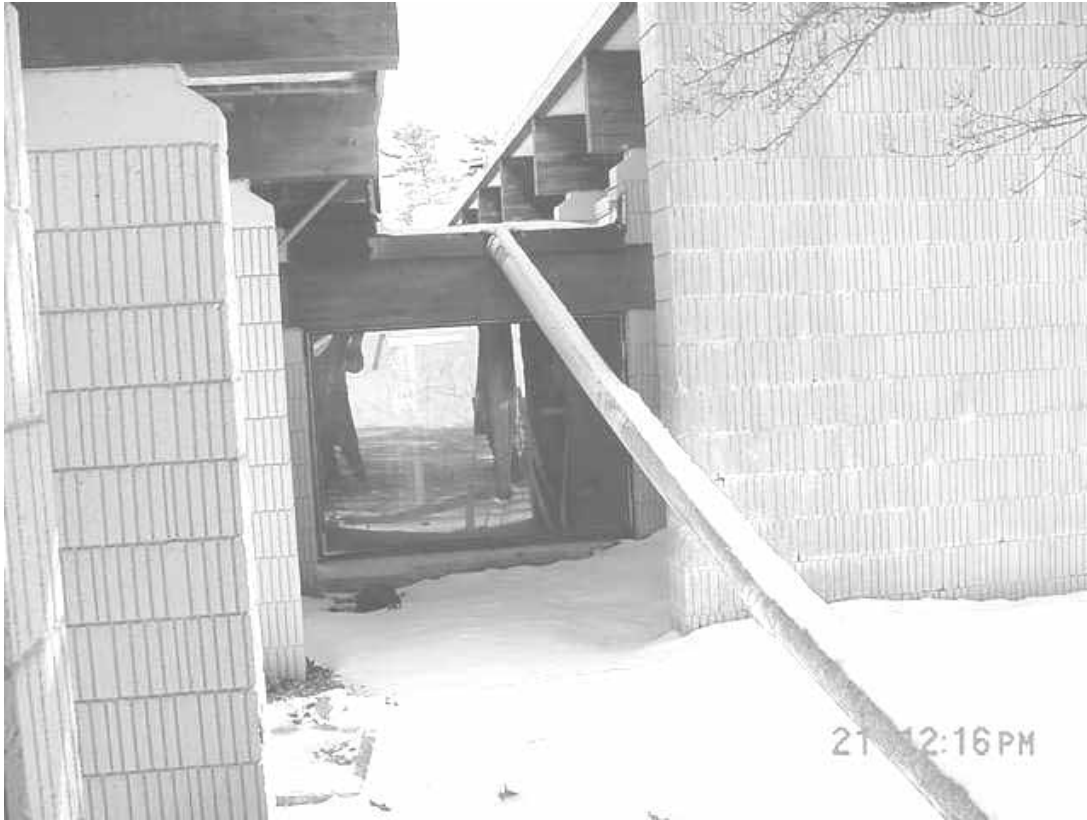
Active roof leaks were reported in a number of areas. Picture 9 illustrates an attempt to drain the roof in an area of chronic water pooling. Mr. Sanborn reported that he planned to contract with a roofing firm to “build-up” this portion of the roof to prevent pooling. Several classrooms ceiling tiles that appeared bowing and disintegrating due to stress (Picture 10). Similar observations were seen in tiles along the roof eaves. These tiles also appeared to have significant damage (Picture 11), and spaces from bowing tiles can provide a means of water penetration into the building. In several cases, these tiles had been removed and replaced with plywood (Picture 12).

Drainage to Help Prevent Water Penetration in Main Hallway

3. Continue with plans to make roof repairs to prevent water from pooling/penetrating.
4. Repair/replace severely water-damaged ceiling tiles/panels in classroom 3 and around the perimeter of the building. Consider temporarily replacing with plywood as shown in Picture 12.

2. Consider total roof replacement including the removal of historical “patches”.
3. Examine the feasibility of enhancing drainage to areas of the roof subject to water pooling. This may include redirecting the pitch of the roof towards drains or installation of new drains.

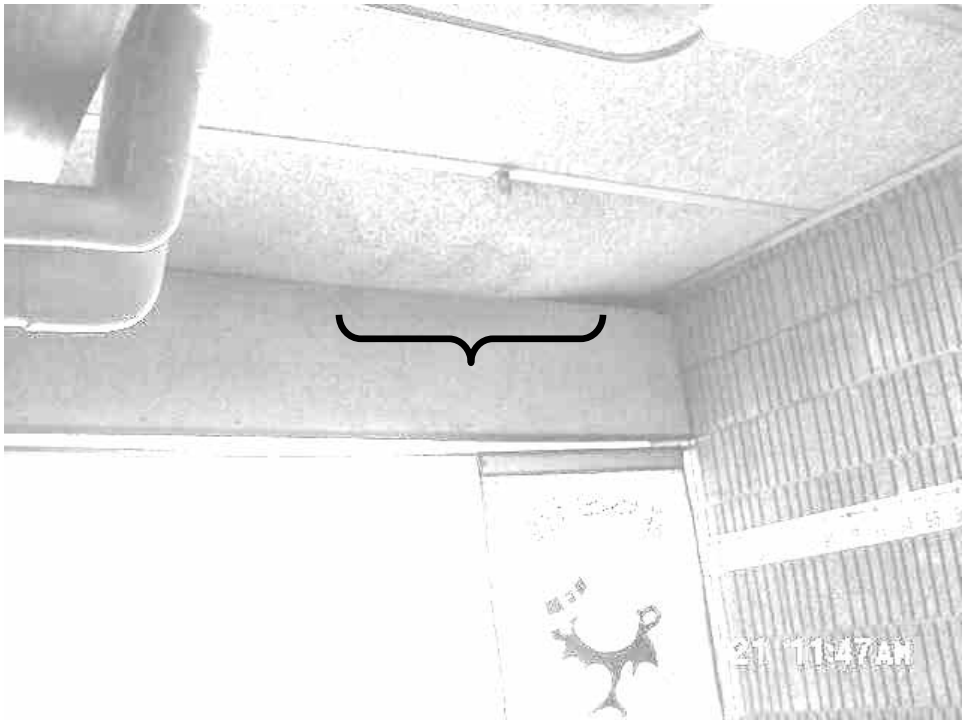
Picture 10

Water Damaged “Bowling” Ceiling Tile in Classroom 3

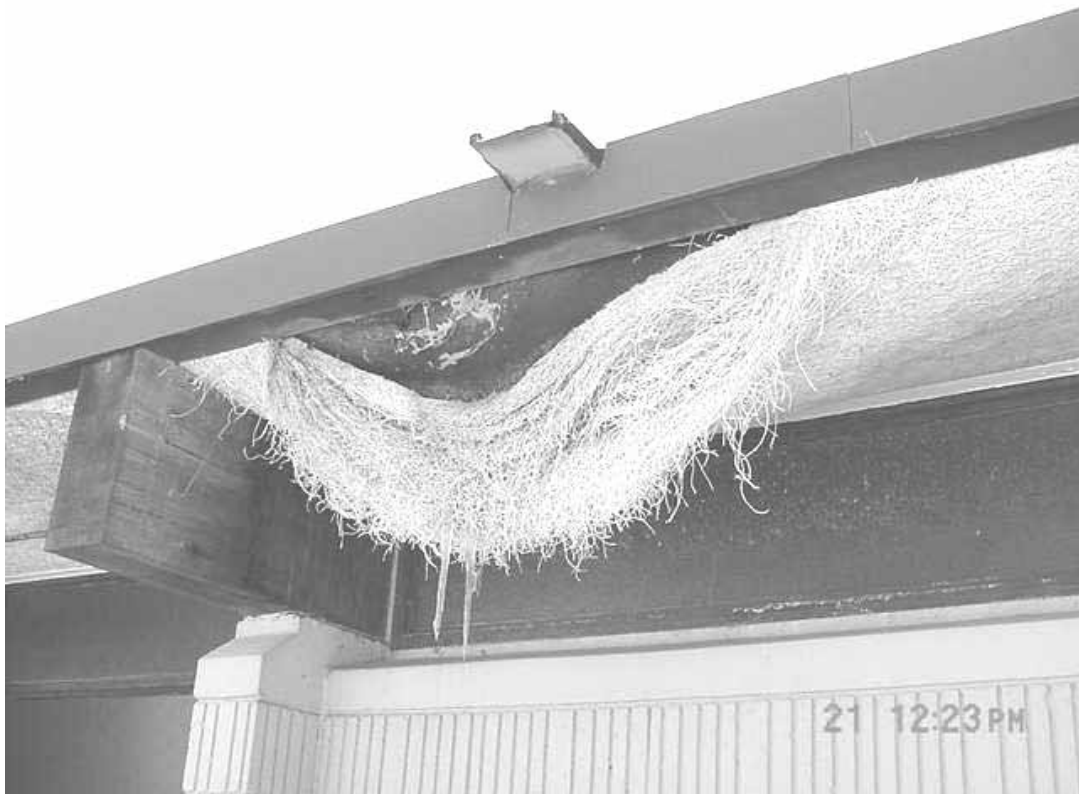
Picture 11

Severely Damaged Ceiling Panel on Exterior of Building

4. Consider total removal/replacement of ceiling tile system.
5. Repair/replace loose/broken windowpanes and missing or damaged window caulking building-wide to prevent water penetration through window frames.

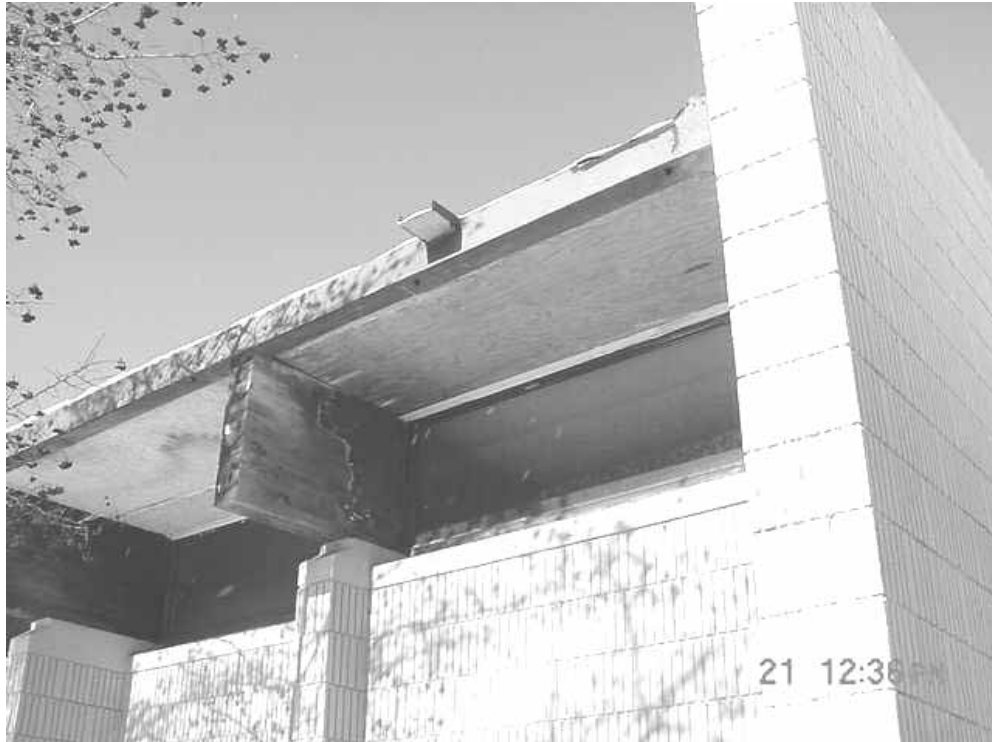
Picture 12

Ceiling Panel Replaced With Plywood

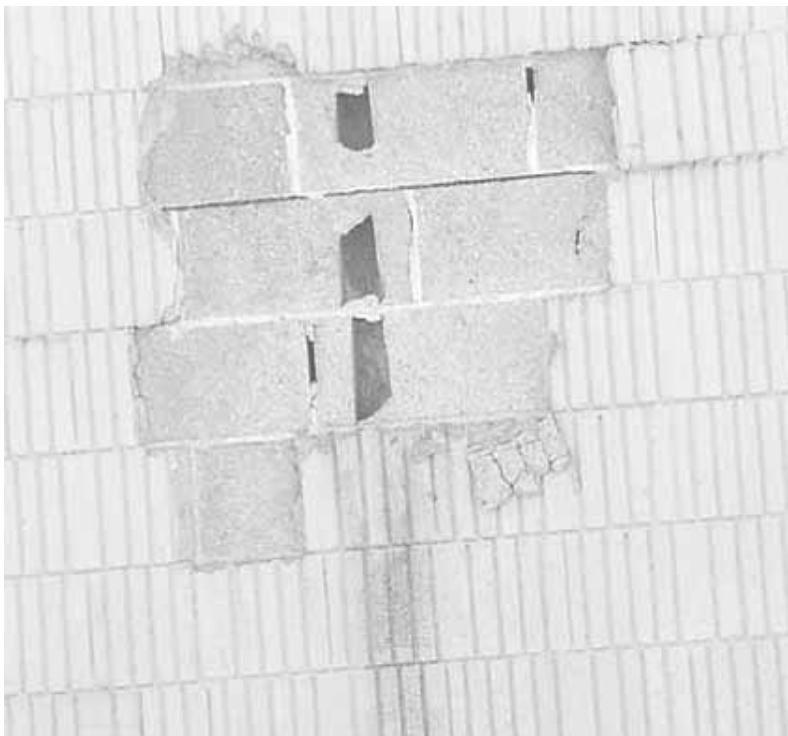
Picture 13

Another potential pathway for moisture to enter into the building includes open holes/damage to exterior walls (Pictures 13 and 14). These breaches to the building envelope can allow water to penetrate the building. Repeated water penetration can result in the chronic wetting of building materials and potential microbial growth. In addition, these holes may provide a means of egress for pests/rodents into the building.

Missing/Damaged Exterior Wall Brick

5. Contact a masonry firm or general contractor to repair holes/breaches in exterior walls to prevent water penetration, drafts and pest entry.
6. Operate all ventilation systems throughout the building (e.g., gym, auditorium, classrooms) continuously during periods of school occupancy independent of thermostat control to maximize air exchange. To increase airflow in classrooms, set univent controls to “high”.

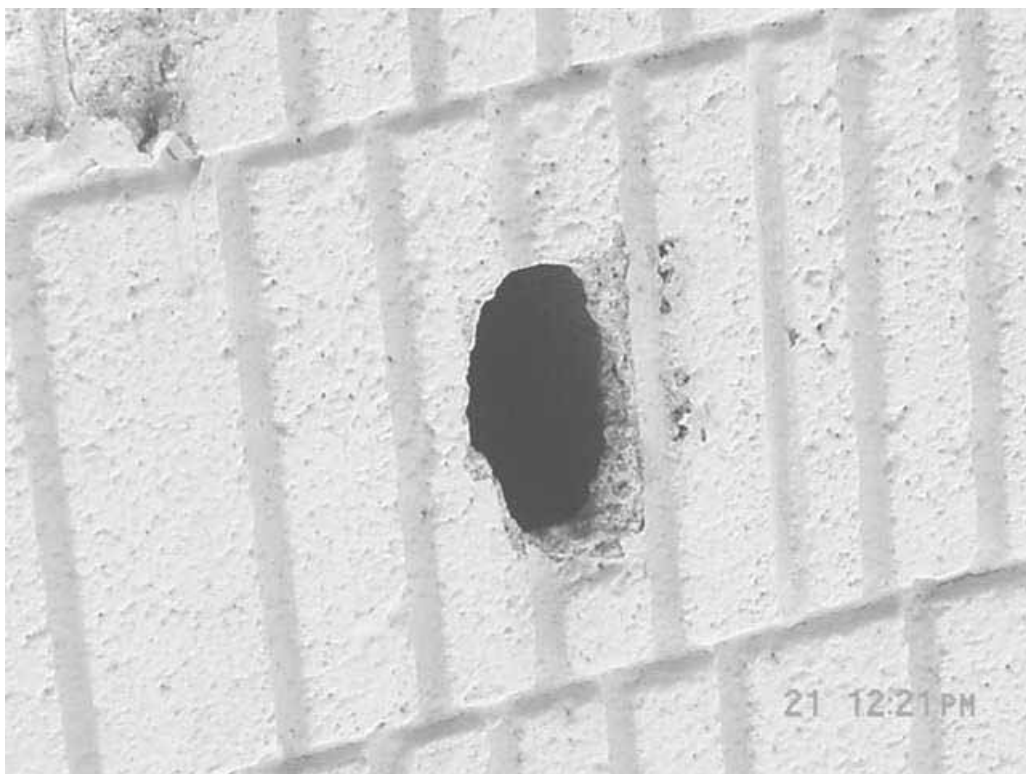
Picture 14

Large Hole in Exterior Wall

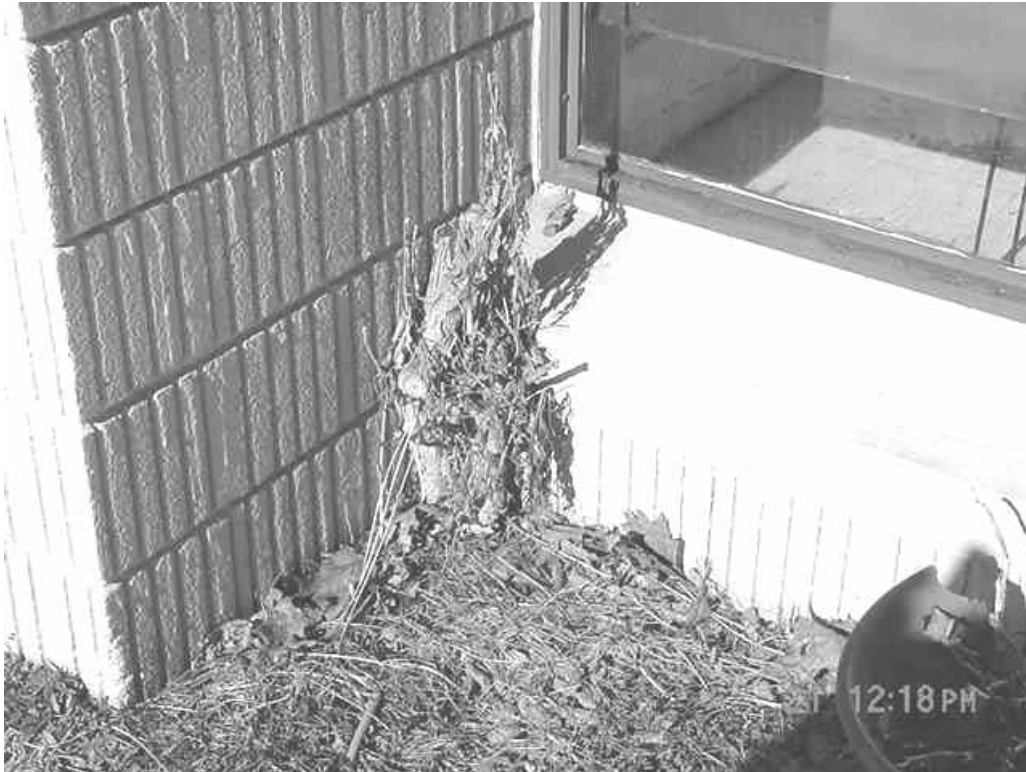
Picture 15

Tree Stump Growing Against Foundation/Exterior Wall

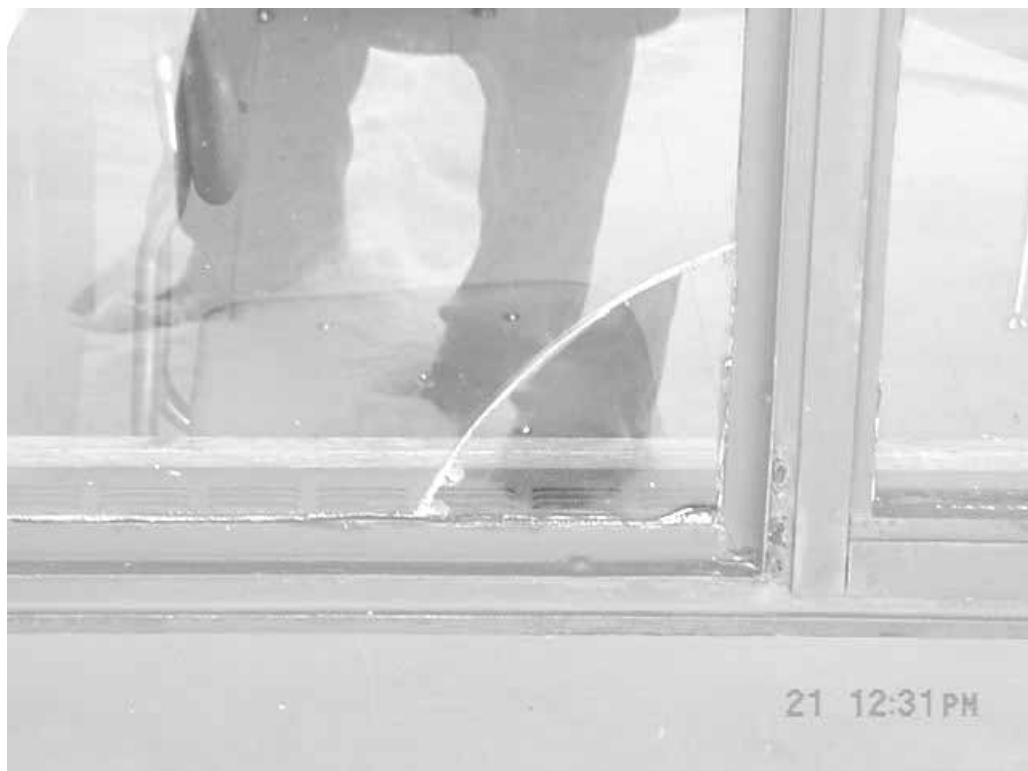
Picture 16

A number of areas had loose or broken windowpanes through which drafts could be felt (Pictures 16 and 17). These conditions indicate that the window's water seal is no longer intact. Under certain conditions, water penetration through window frames can lead to water damage and/or potential mold growth. Another possible source for mold growth is the storage of porous items beneath classroom sinks; these areas tend to be moist environments due to plumbing fixtures. In classrooms throughout the school, items such as newspapers, magazines and cardboard were stored in these cabinets; some of the paper goods appeared to have been water damaged.

Broken Windowpane

11. Repair/replace broken windows; re-seal loose window frames to prevent drafts and water penetration.
12. Ensure all plants are equipped with drip pans. Examine drip pans for mold growth and disinfect areas of water leaks with an appropriate antimicrobial where necessary. Move plants away from ventilation sources in classrooms.

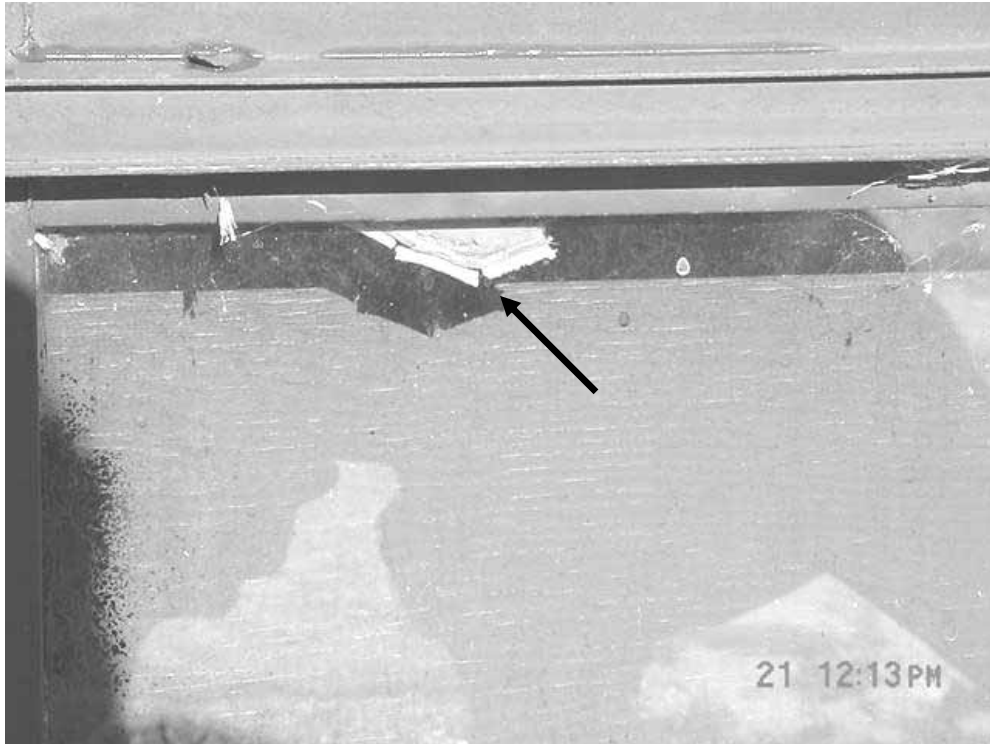
Picture 17

Failing Caulking around Windowpane

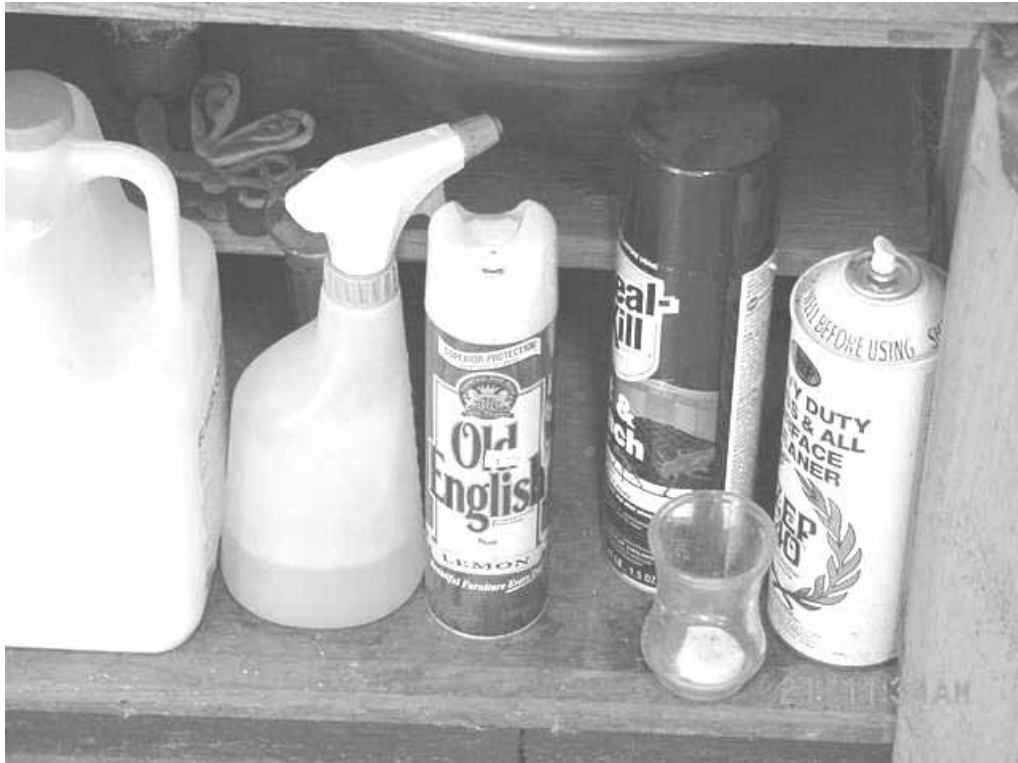
Picture 18

**Aerosol Cans of Pesticide, Furniture Polish, All Purpose Cleaner and an Unlabeled Spray Bottle
beneath Classroom Sink in Unlocked Cabinet**

15. Conduct a thorough inventory to ensure pesticides are removed from classrooms. Use the principles of integrated pest management (IPM) to rid the building of pests. A copy of the IPM recommendations can be obtained from the Massachusetts Department of Food and Agriculture (MDFA) website at the

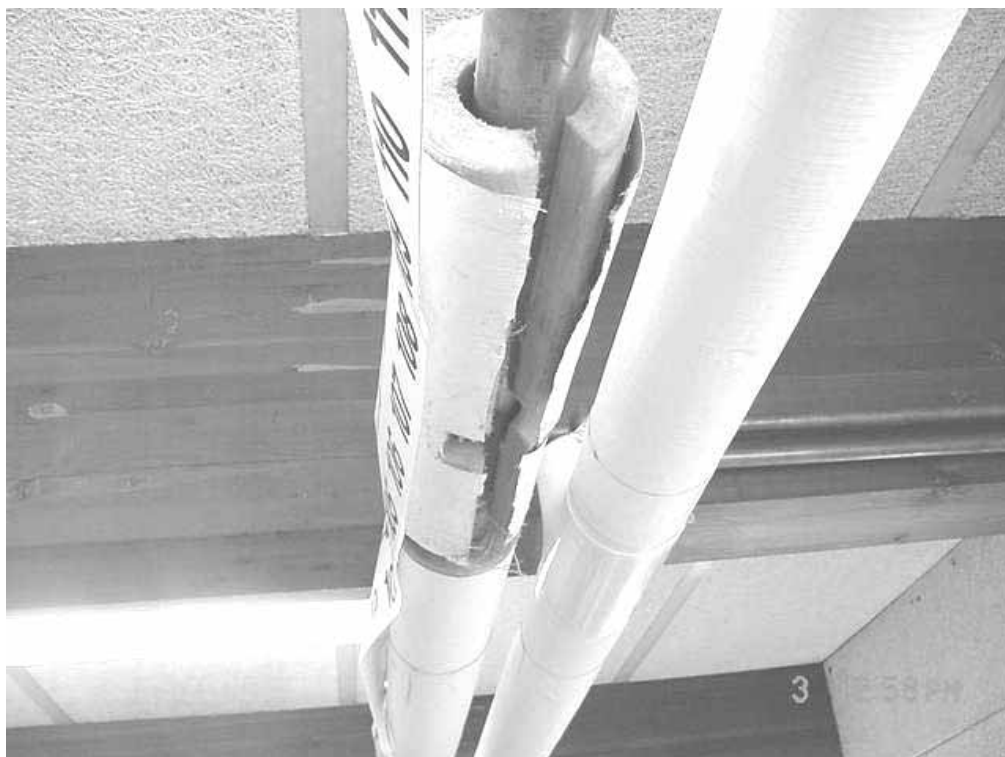
Picture 19

Exposed Fiberglass Pipe Wrap in Classroom

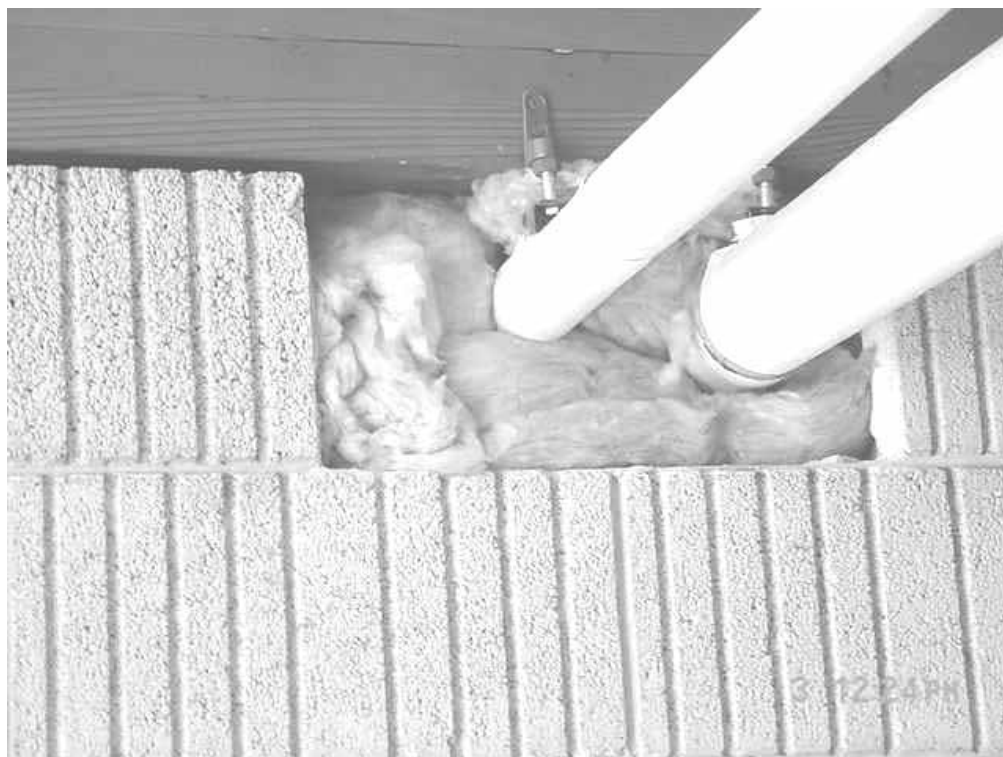
Picture 20

Exposed Fiberglass Insulation in Classroom

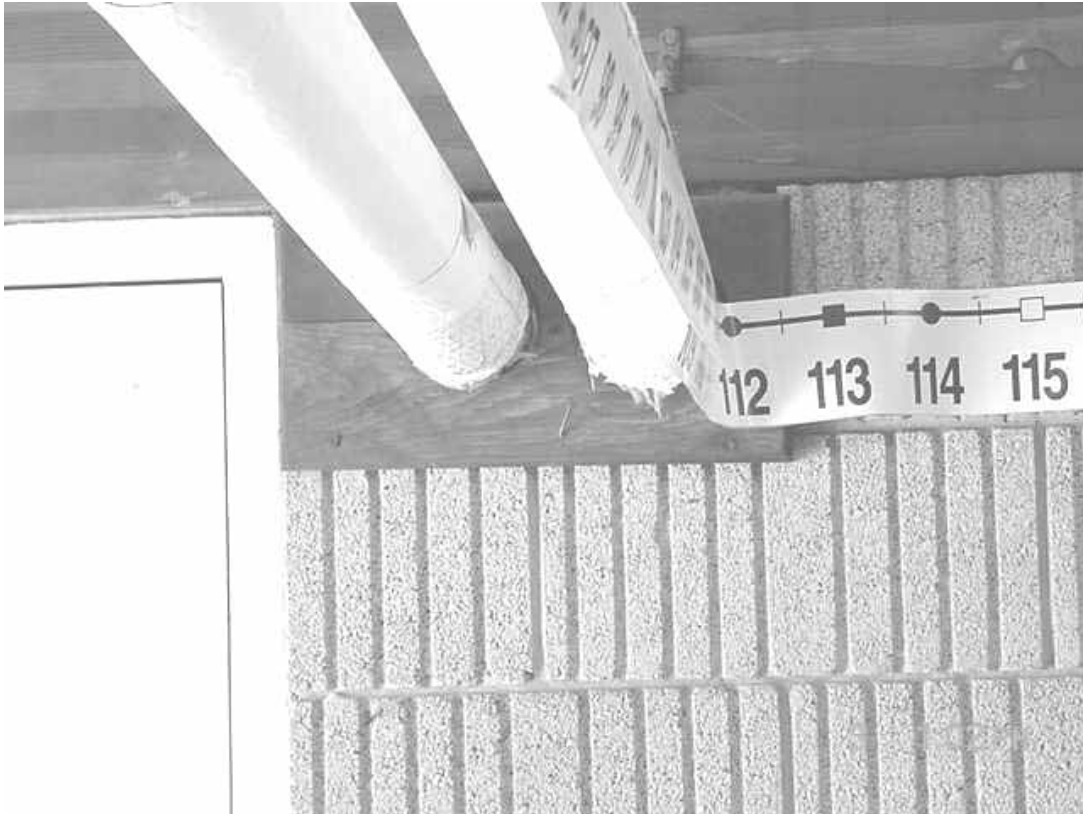
Picture 21

Plywood Installed over Fiberglass Insulation

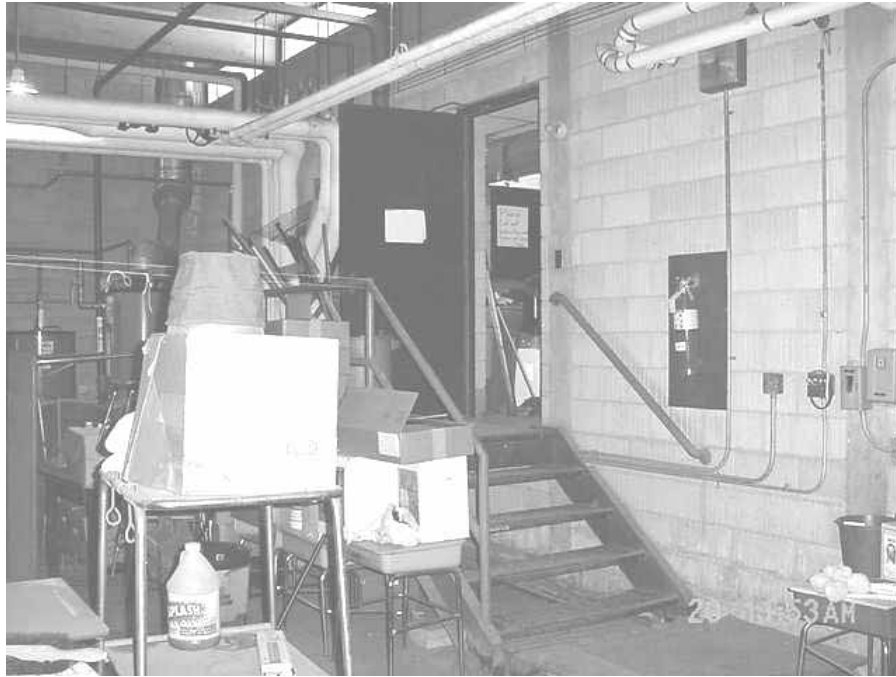
Picture 22

Fuel/boiler room odors were detected in the hallway between the boiler room and the cafeteria. The boiler room door was found pegged open, allowing odors to migrate into adjacent areas (Picture 22). The door also did not have a means to close properly because the doorknob had been removed (Picture 23).

Boiler Room Door Propped Open

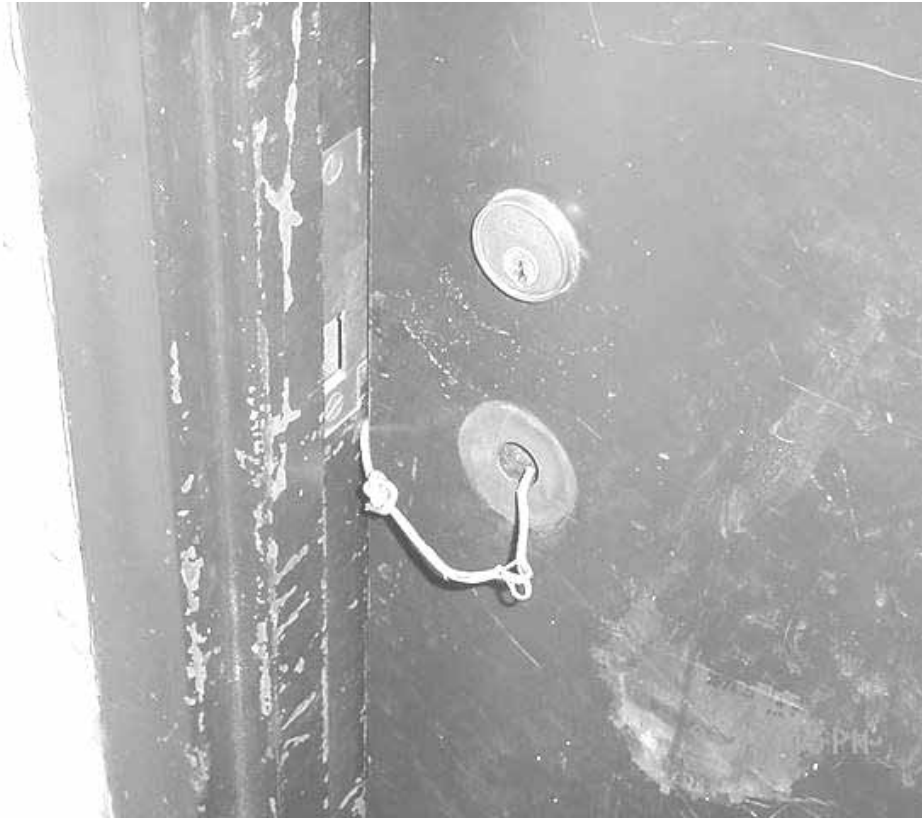
Picture 23

Boiler Room Door Note Doorknob is Removed
